# **SAFETY OF LIGHT COMMERCIAL VEHICLES IN THE LIGHT OF THE RESULTS OF ACCIDENT ANALYSES AND TESTING**

**Paper No. 181**

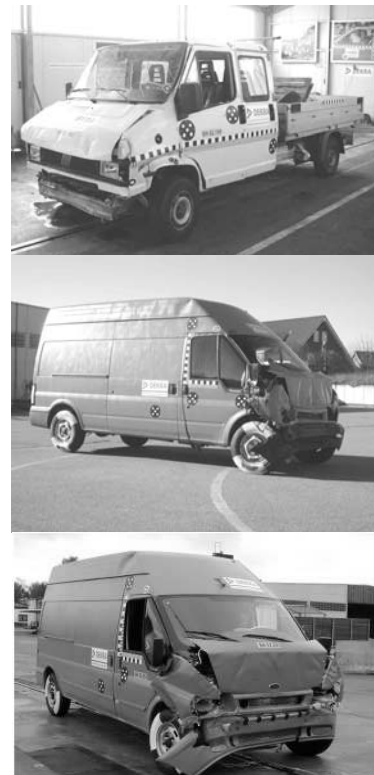
In line with the test conditions, the fronts of the vehicles were deformed over their entire widths, as shown in Figure 21.

The Ford Transit has two sturdy longitudinal frame elements. These contributed symmetrically towards absorbing the impact energy by converting it into deformation work. No fluids leaked from the tanks of either vehicle following the crash. The driver and passenger airbags of both Ford Transit vehicles

**Figure 21: Deformation of the vehicle fronts (top picture: Fiat Ducato after impact at 31.7 km/h; centre: Ford Transit after impact at 48.1 km/h; bottom: Ford Transit after impact at 48.4 km/h)**

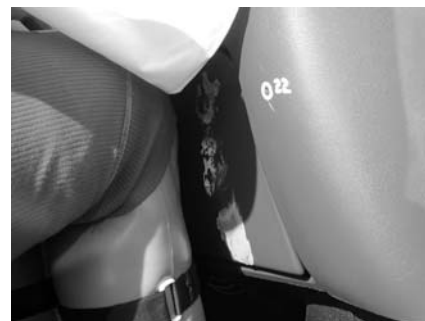
were deployed. The survival space for the occupants remained virtually fully intact in all test vehicles. There were some folds to be seen in the floors/foot spaces of the vehicles. It was possible to open the driver and passenger doors of the two Ford Transit manually without tool – contrary to the doors of the Fiat Ducato, which had to be opened with a tool. In all tests, the dashboards / instrument panels showed traces of knee and lower leg impact by the dummies. For example, Figure 22 shows the situation in the region of the outer co-driver dummy's knee in the Ford Transit in test SH 02.018.

**Figure 22: Situation in the region of the outer co-driver's knee in a Ford Transit, showing traces of knee and shin impact, in test number SH 02.018**

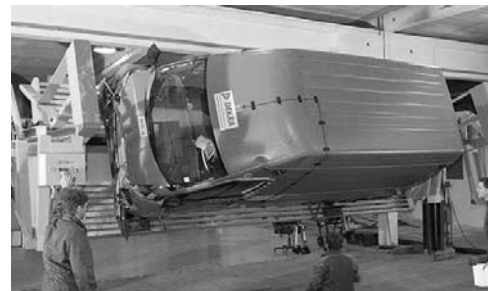
One of the vehicles (test SH 02.018) was subjected to a so-called static roll-over test in order to check the leak-tightness of the tanks in accordance with FMVSS 301 (Figure 26). In this test, the vehicle is rotated, in stages, about a longitudinal axis by two full revolutions. After each quarter of a turn, i. e. in the 0°, 90°, 180° and 270° positions, the vehicle is held stationary for 5 minutes. During this test, not more than 142 g of fuel per 5 minute period may leak out. The vehicle passed this test.

**Figure 26: Test to check for tank leakage in accordance with FMVSS 301**

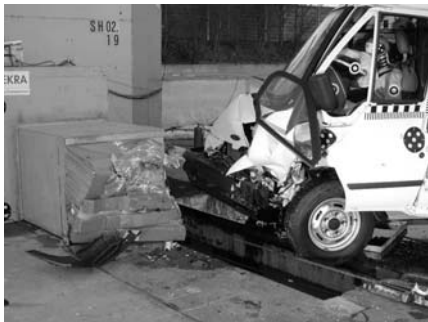
The one-sided action of the impact forces on the front of the vehicle is a typical characteristic of offset crashes. Correspondingly, the longitudinal frame element being directly hit has to convert more of the impact energy than the one on the side away from the impact. Figure 28 shows the deformed vehicle in the final rest position.

**Figure 28: Front of the Ford Transit, shown in the final position after collision at 56.2 km/h and with a 40% coverage of the obstacle in an offset crash test**

Although there are no safety-relevant legal regulations concerning goods vehicles with respect to offset crash tests, the Ford Transit also showed structural characteristics in this test which were generally acceptable. The occupant cell did not break apart. The foot space was damaged more severely in front of the driver’s seat than during the full-frontal tests. The floor was folded in the driver’s area. Both the steering wheel and the pedal assembly intruded further into the inner space than after the full-frontal tests of the same vehicle type.

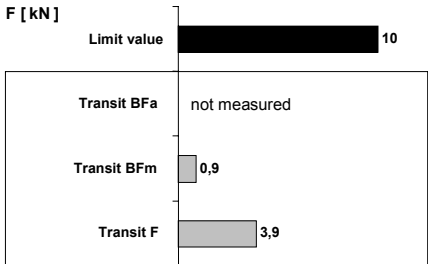
All measured dummy stresses were below the respective biomechanical limits. To illustrate this, Figures 29 to 31 show the measured HIC, thorax deceleration  $a_{3ms}$  and the maximum compressive forces in the left thigh. The value ranges are:  $HIC = 112 - 229$ ,  $a_{3ms} = 27 - 38$  g and  $F = 0.9 - 3.9$  kN.

**Figure 29: Head stresses of the dummies, determined as HIC values (F: driver, BFm: middle passenger, BFa: passenger on outer seat) determined in offset crash test SH 02.019**

**Figure 30: Thorax deceleration values,  $a_{3ms}$ , experienced by the dummies, determined in offset crash test SH 02.019**

**Figure 31: Maximum compressive forces F measured in the left femur of the dummies, determined in offset crash test SH 02.019**
